**SAS Superstructure**

Daily Diary Report by Bid Item

Contract No.: 04-0120F4

Diary #: 012 Const Calendar Day: 903 Date: 28-Feb-2012 Tuesday

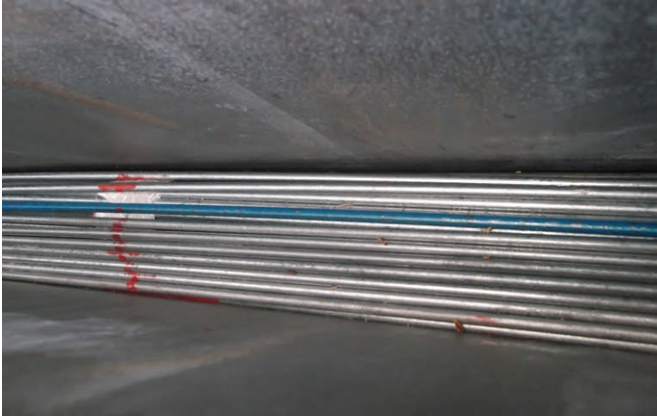
I have continued to document the presence of 10 wires on top of the strands instead of 11, in the troughs of the both saddles in the tower and particularly the North side. There are troughs where the widths are not 61.5mm wide, thus, resulting in varying degrees of problems with the strands installed in these locations. These problems range from having the outside wires disappear in sections only to re-appear in others to wires on the top tier being replaced by wires from the 2nd tier (definitely at the South end where they do not use tapes) to the very wide troughs of up to 80mm where the wires are all over the place . The attached Photos demonstrate these problems for strands # 64, 65, 66, and 67. I have asked Roman and Warren to look at this problem and inform us of their assessments.

WidthIssuesatTheNorthSaddle
